SECTION 7.6 Drainage Report and CCTV Videos

7.6.1 Drainage Report

Project Name: Calder Park- Wakefield
Project Description: WinCan Import in Miraculix Standard
Project Date: 29/08/2022

Company: Winvic Construction
Description: CCTV Drainage Survey
Contact: Matt Percival
Department: Vertical Build
Street: Calder Park
Town or City: Wakefield

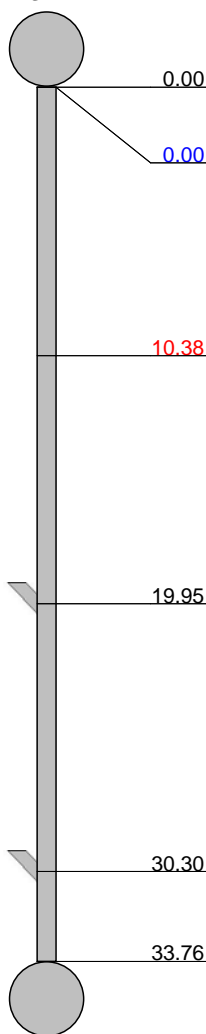
<table><tr><th>Code</th><th>Observation</th><th>MPEG</th></tr><tr><td>B</td><td>Broken pipe at 4 o'clock</td><td>00:00:46</td></tr></table>
